**City Council - Appeal Public Hearing**

**Brief Title:** Set Appeal Hearing - 1413 Main Street

Appeal Hearing - 1413 Main Street

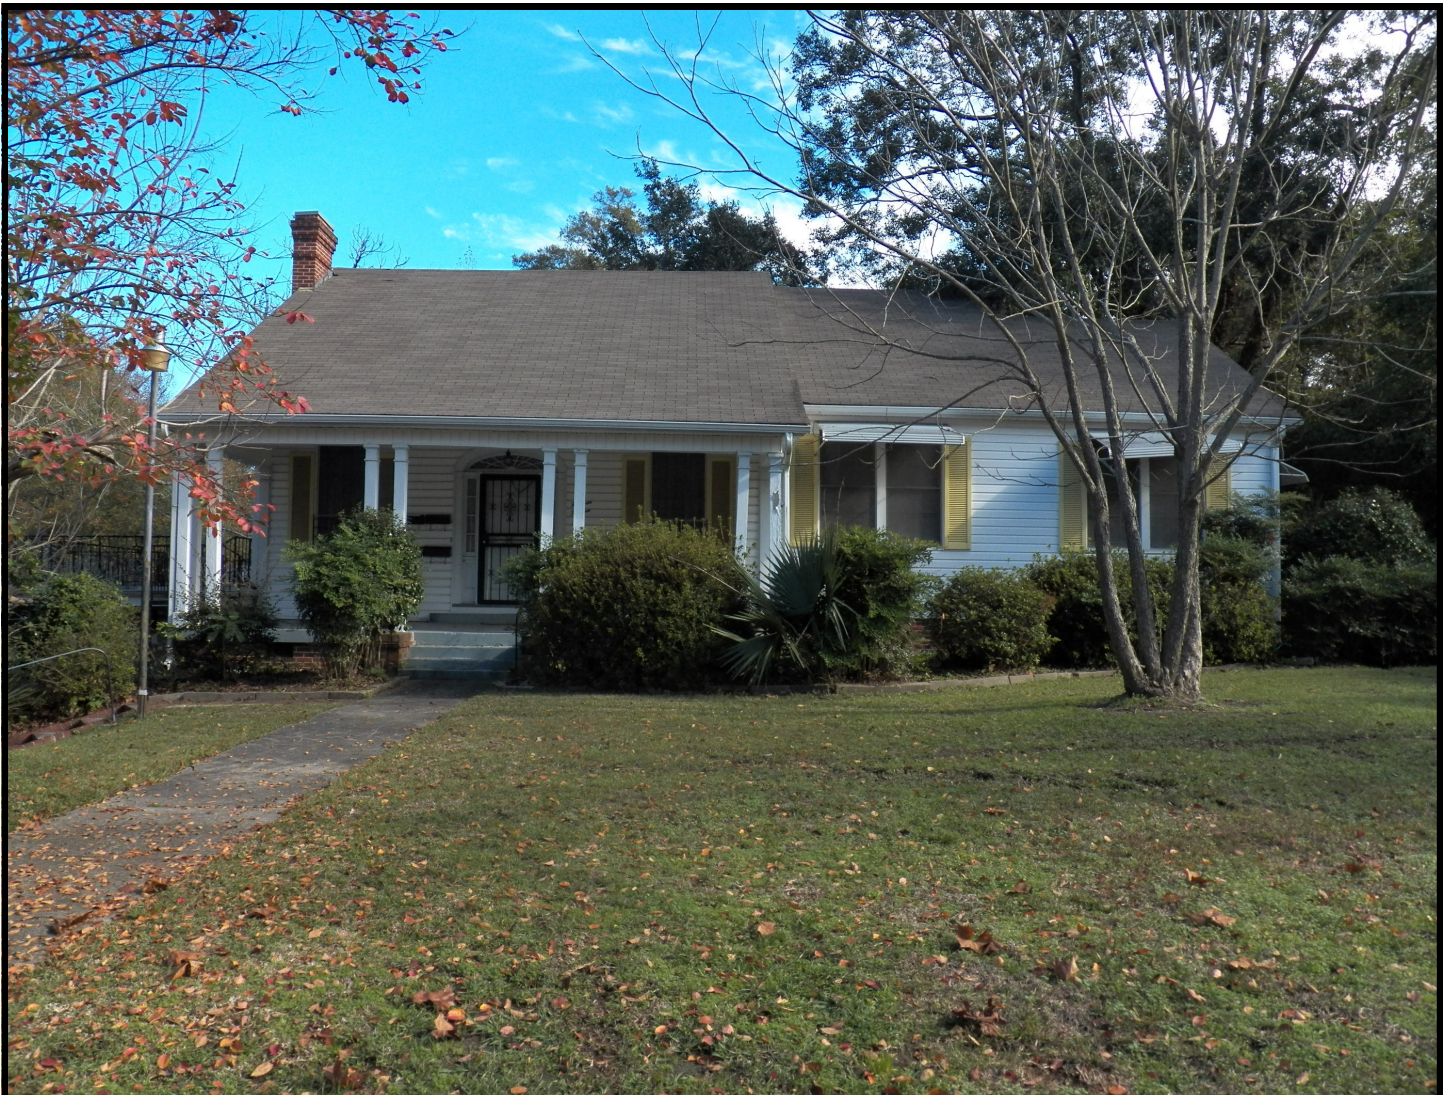
Address: 1413 N. Main St.

Significance: Contributing

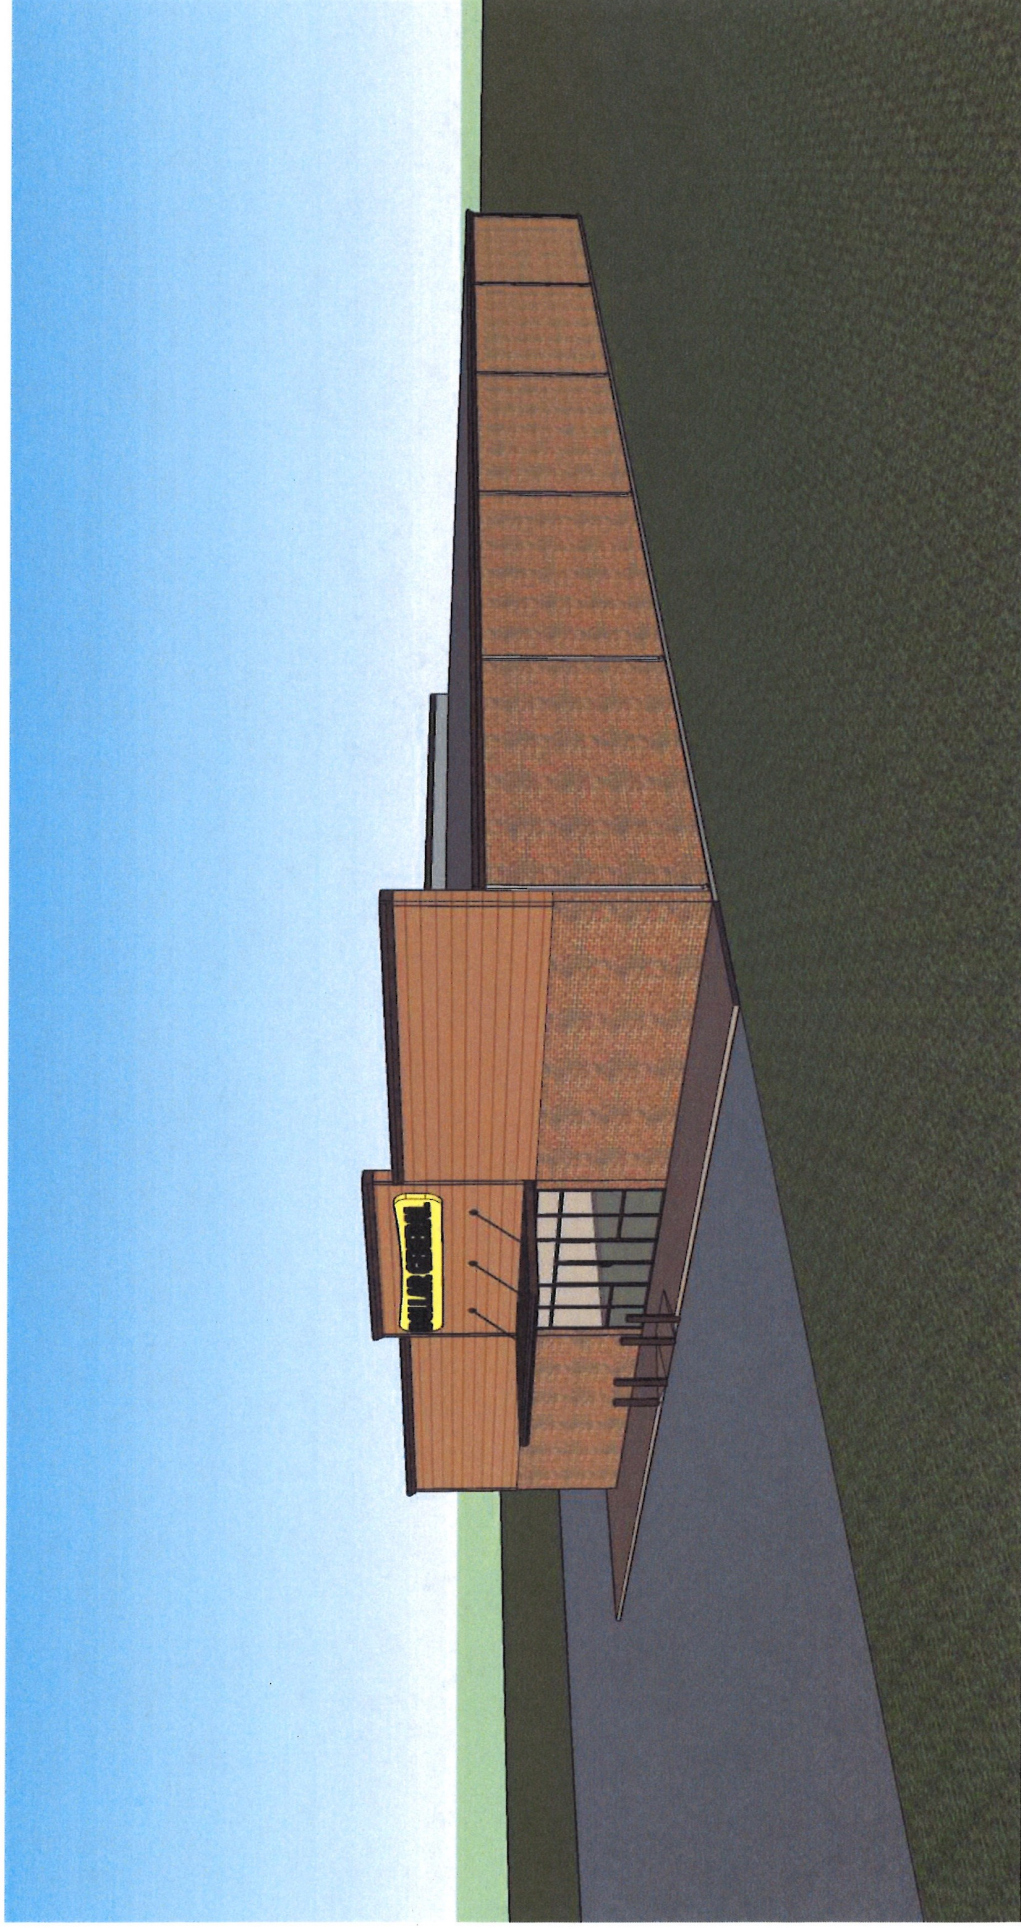
Rendering of proposed building

We propose to construct a new Dollar General Store at this location if the Seller and the Historical Committee agree to tear the house down. The colored rendering are based on the Historical Committee guidelines and we are open to committee recommendations.
